## Product Support Bulletin

**Title: Gapping of Monitor Pickup to Magnetic Disk on Flywheel of Concept 2 Rower Models A & C**

**Date: July 2013 ml**

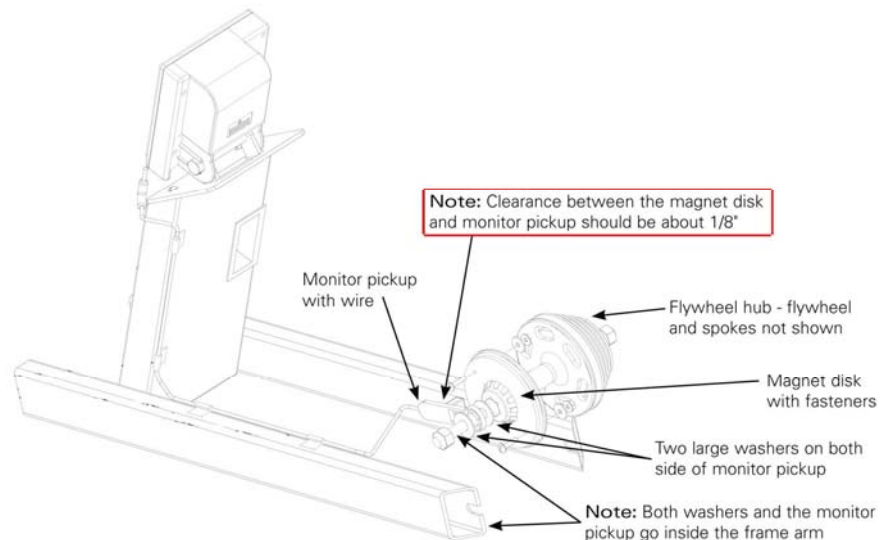
When replacing the monitor pickup or flywheel sensor on a Concept 2 Rower Model A or Model C, it is important to note the proper clearance between the monitor pickup and the magnetic disk.

If the pickup doesn't have proper clearance, the monitor may not perform. You may need to disassemble and reposition the magnetic disk or a washer for proper clearance.
