**NAUTILUS** Service Manual
TreadClimber®, Model TC916
Commercial Series

Model TC9.16

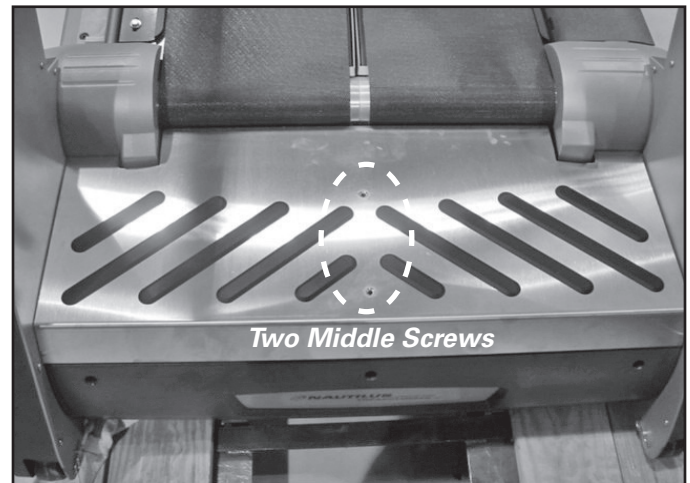
Figure 3-1

- 3-1:** Unplug the unit from the power source and ensure that all power has been drained from the unit.
- 3-2:** Remove two (2) middle screws from Rear Step Cover (see Figure 3-1).
- 3-4:** Lift and slide step cover plate back to remove (see Figure 3-2).
- 3-3:** Remove four (4) screws from Step Weldment (see Figure 3-3).
- 3-5:** Replace rear cover by sliding back into place and re-installing four (4) outer screws.
- 3-6:** Place Step cover onto Step weldment and reattach with two (2) screws (see Figure 3-2 and Figure 3-1).

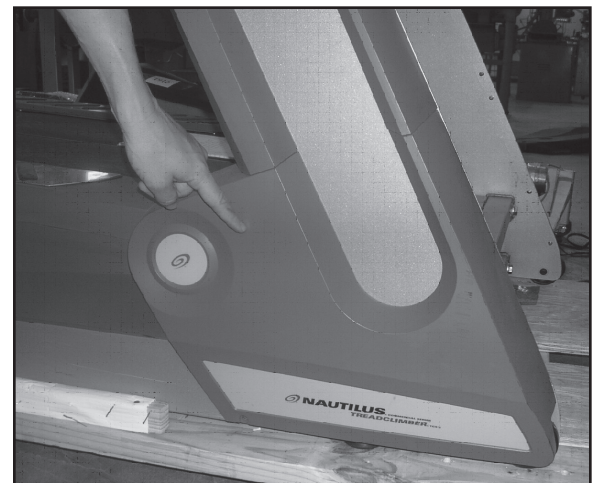
Figure 5-6: Lower plastic parts.

5-5: Remove the Right Lower Cover (P/N - SM17657) and Left Lower Cover (P/N - SM17658). See Figure 5-6 and 5-7.

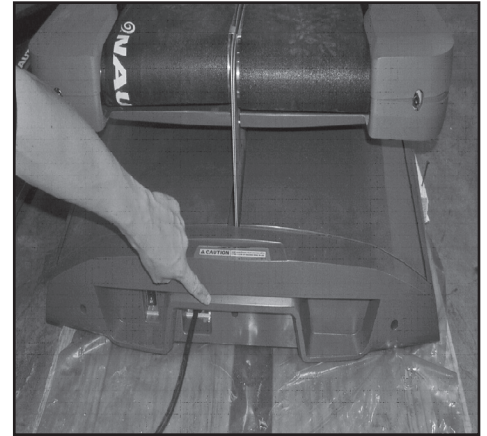
Figure 6-1

- 6-1:** Remove three (3) front plastic screws (see Figure 6-1).
- 6-2:** Remove right and left side plastic covers - four (4) screws each side (see Figure 6-2).
- 6-3:** Remove right and left side pan covers - two (2) screws each side (see Figure 6-3 and Figure 6-4).

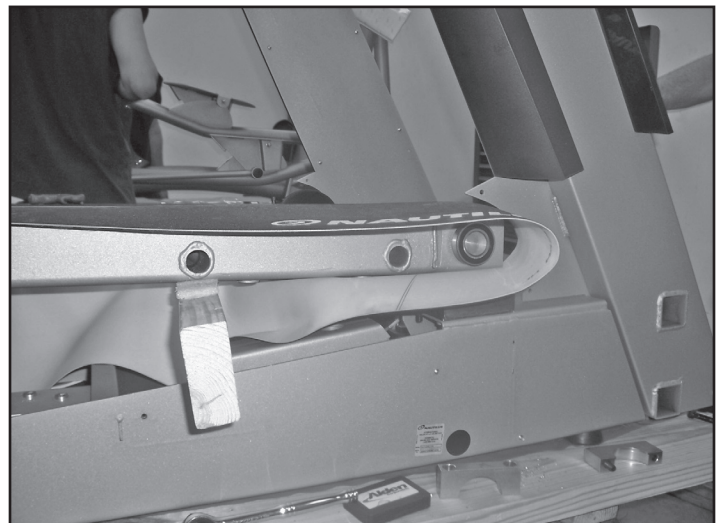
Figure 7: Lift treadle to create clearance.

- 8-12:** Lift treadle to create clearance for walk belt to slide between upright and end of roller (see Figure 7).
- 8-13:** Replace belt and deck using the reverse order of steps 11 through 1.

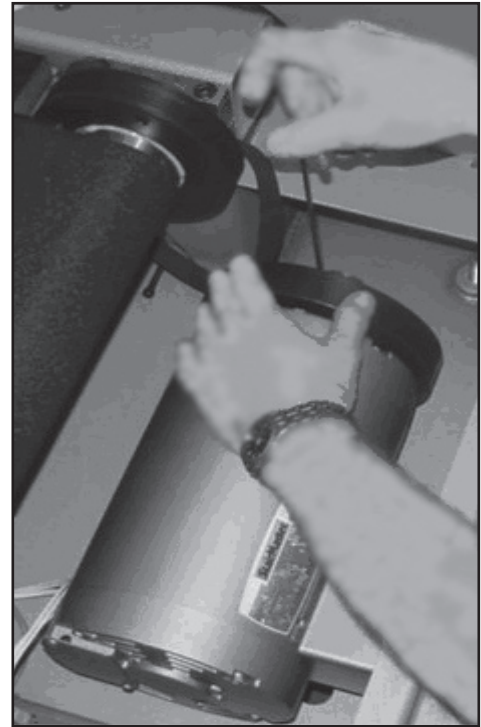
Figure 1: Flywheel set screws
